BUTLER'S LAKE DAM

BUTLER'S GOLF COURSE  
DAC W31-81-C-0027  
PHASE I INSPECTION REPORT  
NATIONAL DAM INSPECTION PROGRAM

Butler's Lake Dam (NDI Number PA-01067,  
PennDER Number 2-29) Ohio River Basin,  
Drennen Branch, Allegheny County,  
Pennsylvania. Phase I Inspection Report.

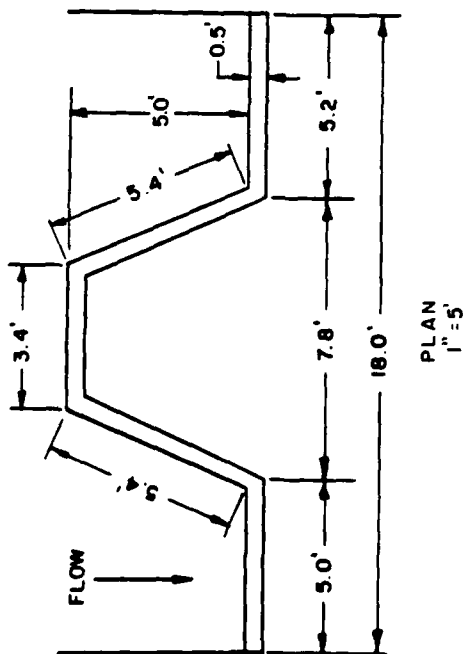
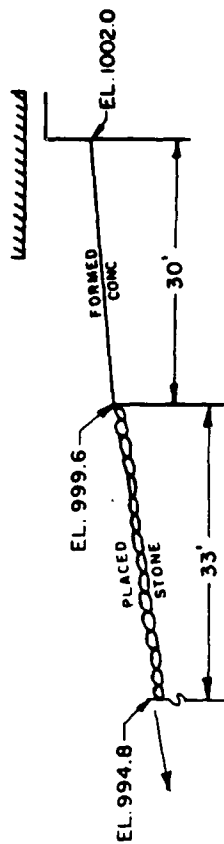
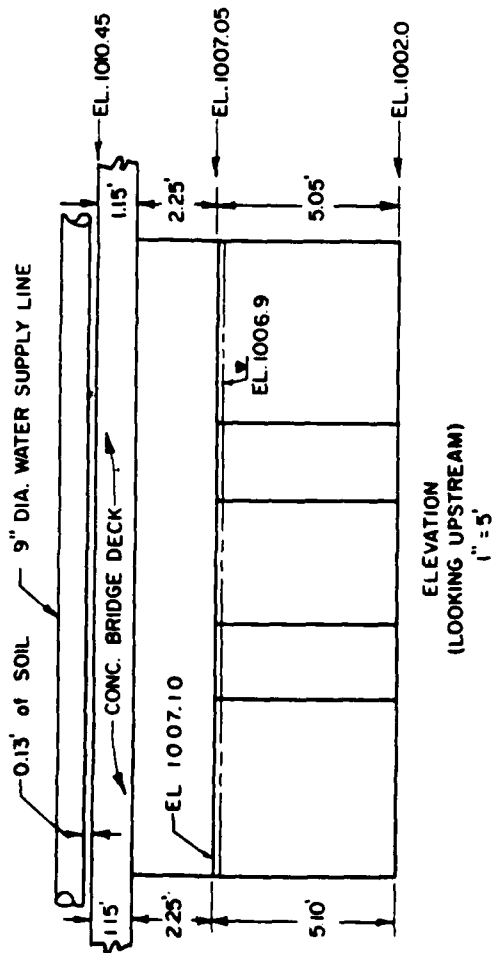
DATE: MAY 1981  
SCALE: AS SHOWN  
DR: JF CK: JEB  
DWG. NO. 80138N-3

# WEIR

# SPILLWAY PROFILE

SCALE:  
HORZ. 1" = 20'  
VERT. 1" = 20'

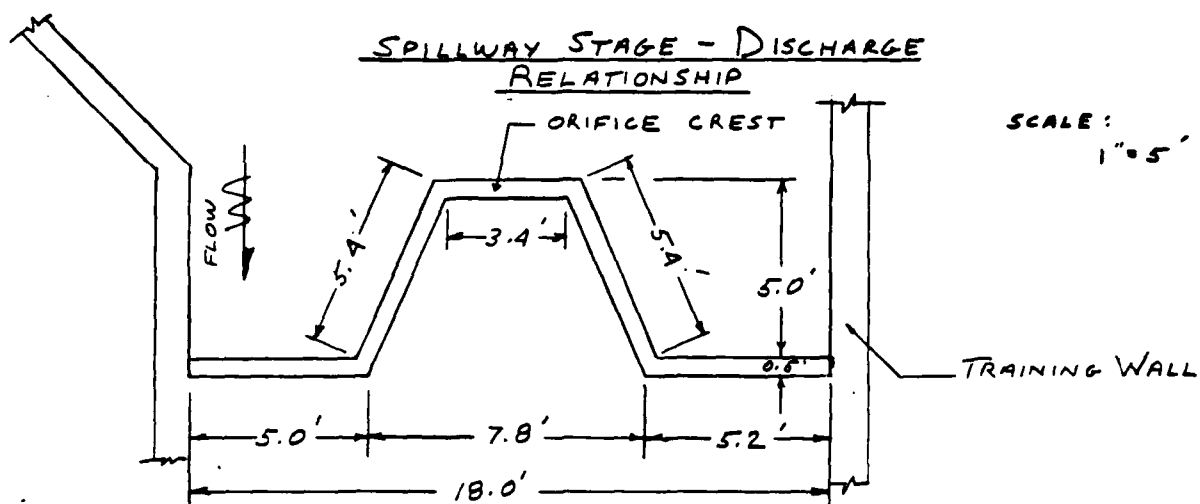
## PLAN

Job BUTLER'S LAKE DAM Job No 80138-N  
Subject DISCHARGE RATING DATA  
Made By SGM Date 15 DEC 80 Checked KBR Date 1-14-80

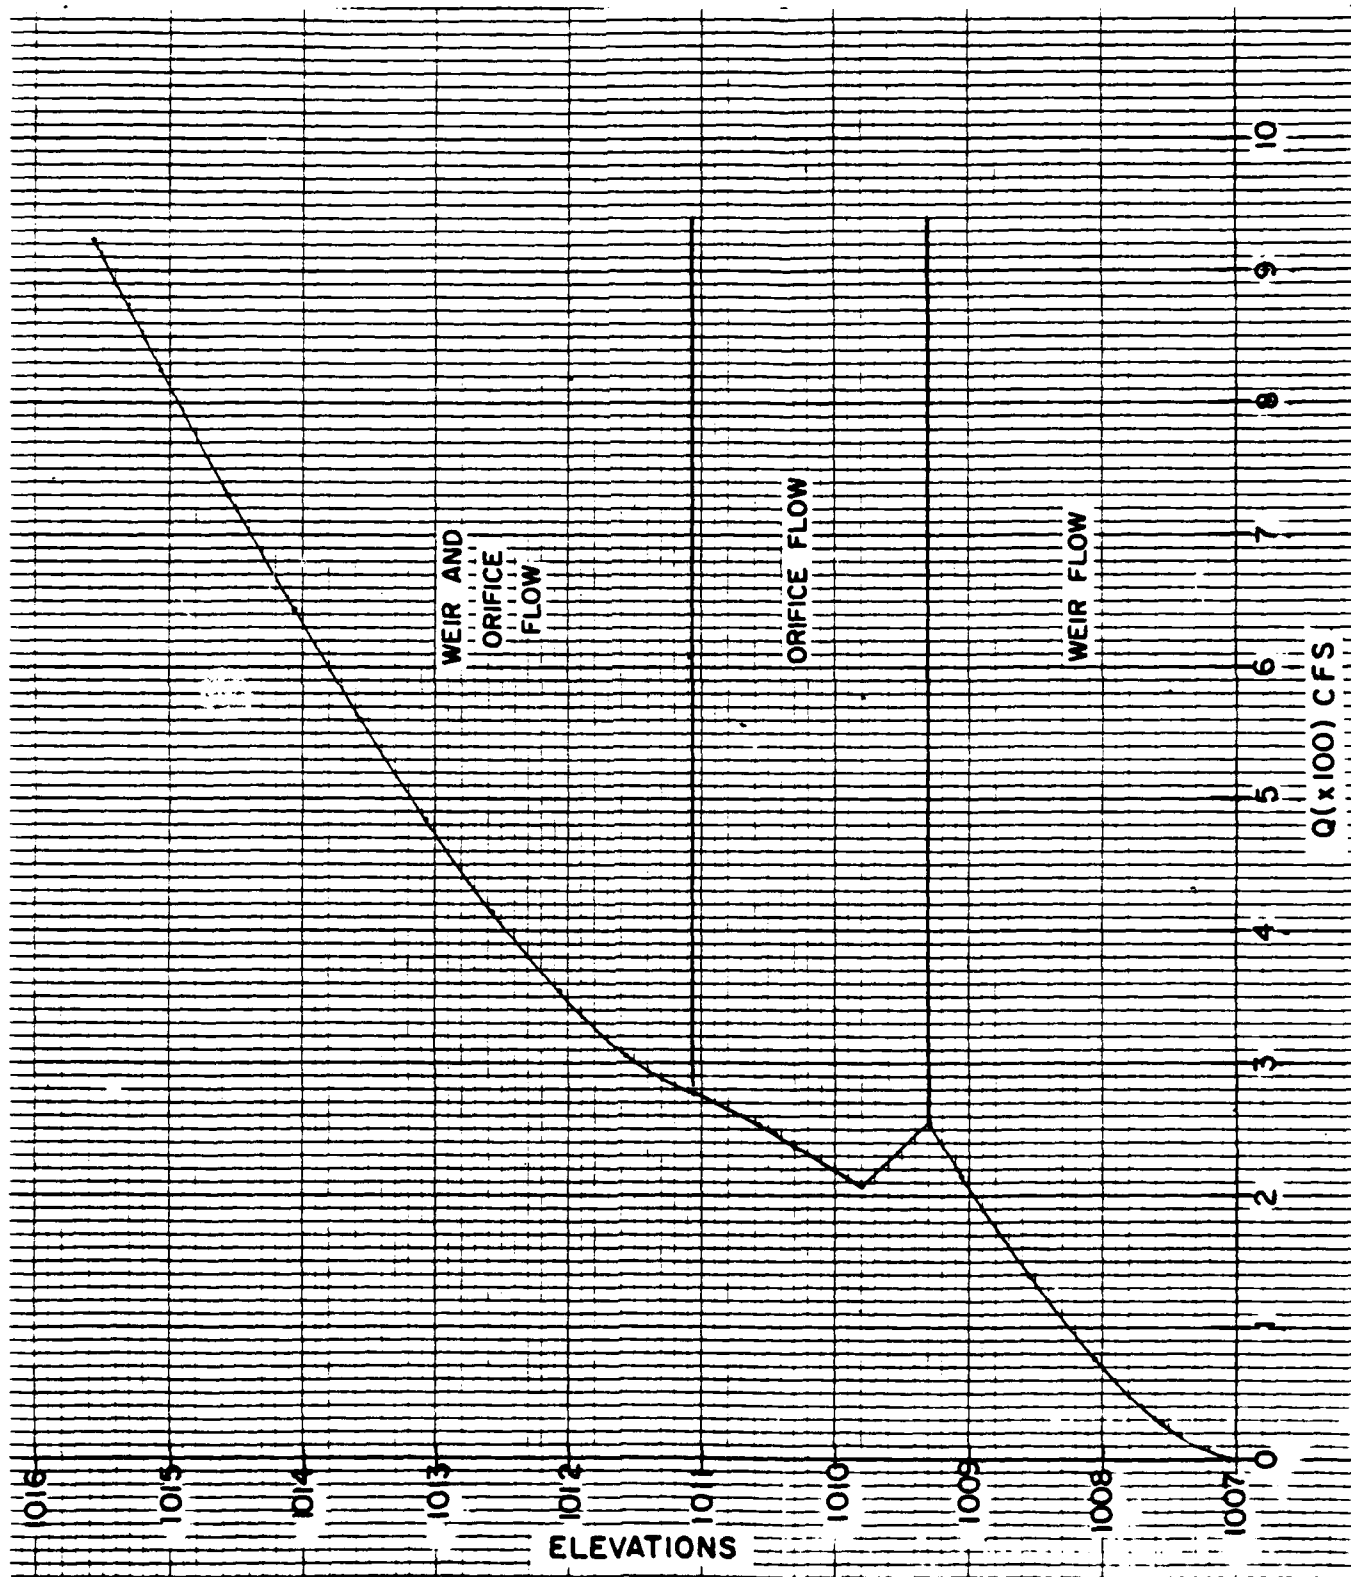
Job BUTLER'S LAKE DAM Job No 30234  
Subject DISCHARGE RATING CURVE  
Made By SGM Date 15 DEC 80 Checked PH Date 4/15/81

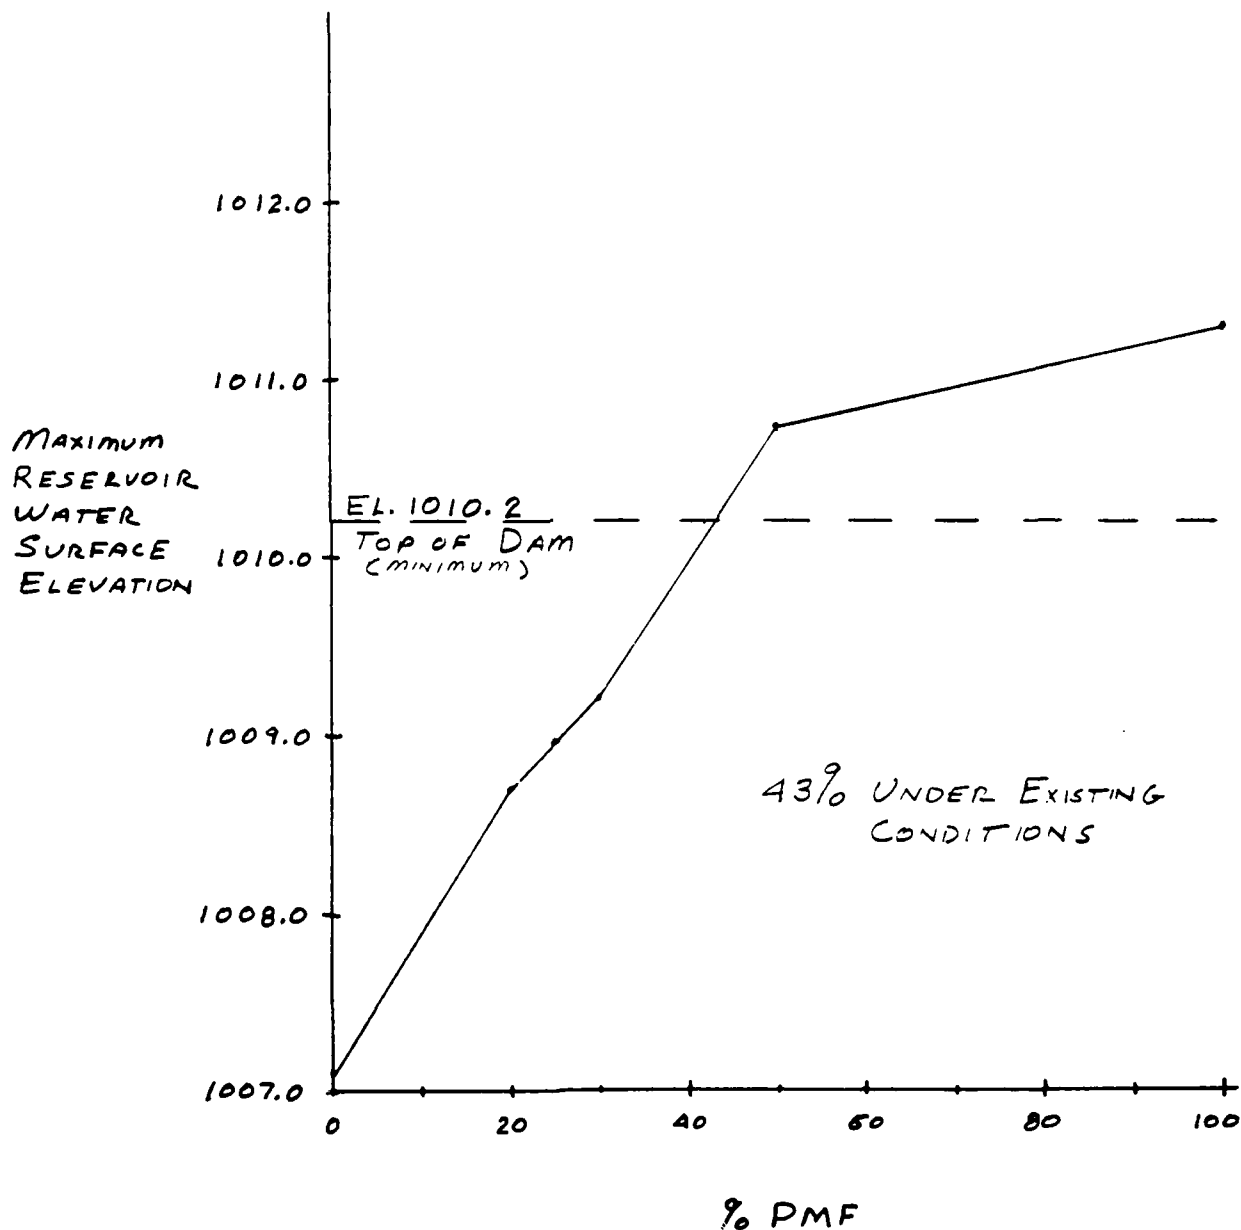
Subject HYDROLOGIC PERFORMANCE PLOT

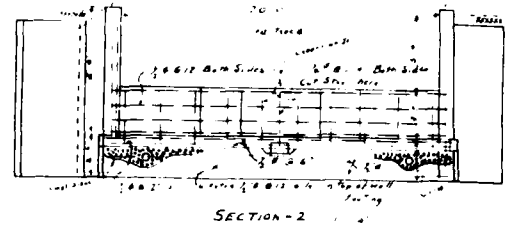
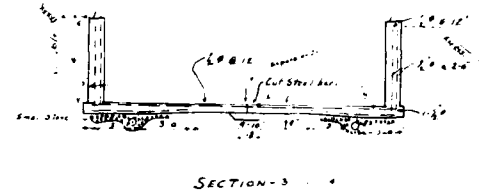
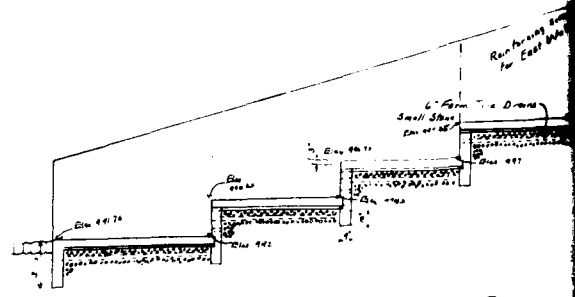
SECTIONS THROUGH DAM  
Scale 1/100

All Concrete to be  
placed in place  
as specified

Type C  
Type B

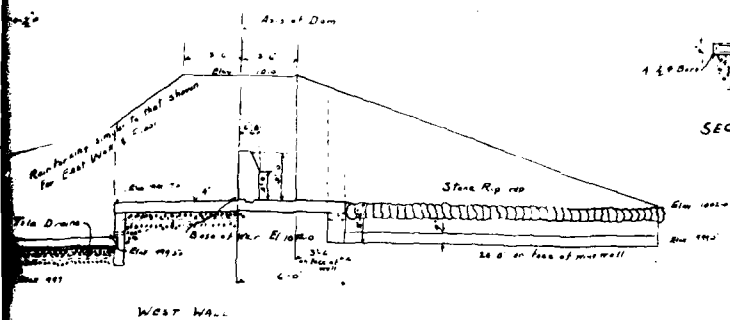
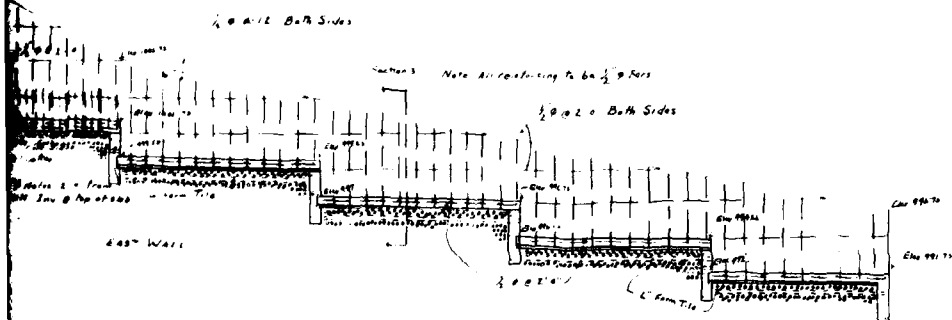
DEVELOPED ELEVATIONS OF SPILLWAY  
Scale  $\frac{1}{4}'' = 1'-0''$

PROPOSED RESERVOIR OR LAKE. SHEET NO. 2  
TO BE SITUATED ON THE  
HEADWATERS OF BRAYS RUN ELIZABETH TWP ALLEGHENY COUNTY PA  
AND OWNED BY
